New temporary option in BUDS to reset/clear cluster as new_139510

This new temporary reset option in BUDS will allow to flash the cluster for MY21 and MY22 units only.

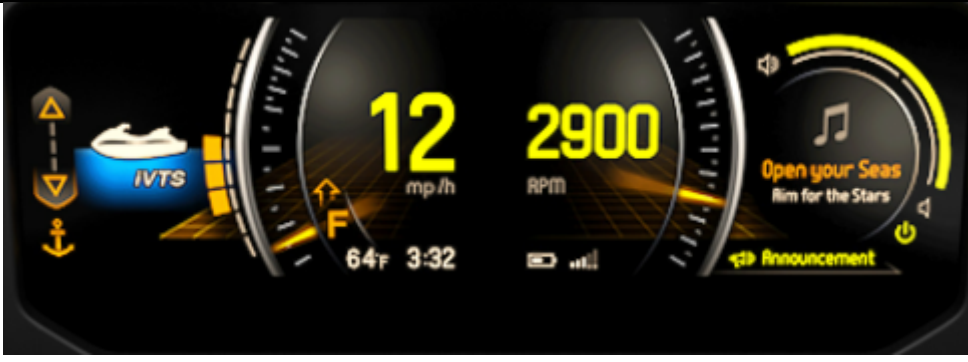
Resetting Cluster as service component compatibility

Modules	Products applicable
Compact Digital Gauge

Ski-Doo ONLY MY21 MY22
Small compact cluster

ATV-SSV-PWC-Ski-Doo ONLY MY21 MY22
Mid-Range compact cluster

ATV-SSV-PWC-Ski-Doo ONLY MY21 MY22
Hi-End dual-screen color cluster

Can not be reset DO NOT USE RESET FUNCTION
