PWC Gen2 iBR Diagnostic Tips - Electrical Explained - 133416

Troubleshooting best practices with detailed view of the iBR connector, verifications to perform, and what to watch out for.

Problem

Many iBR's are replaced due to incorrect diagnostic. After further analysis, external problems are found to be the cause of the iBR system fault.

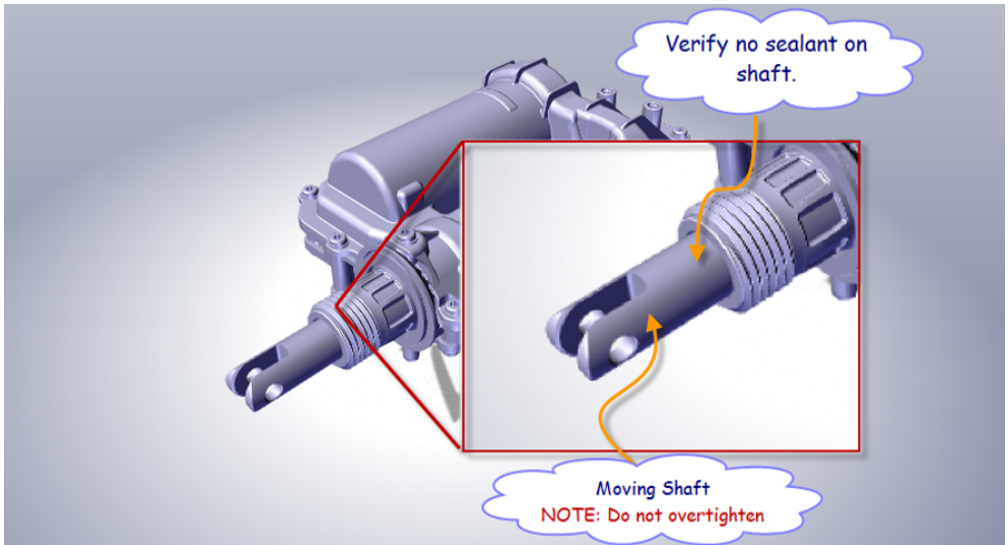
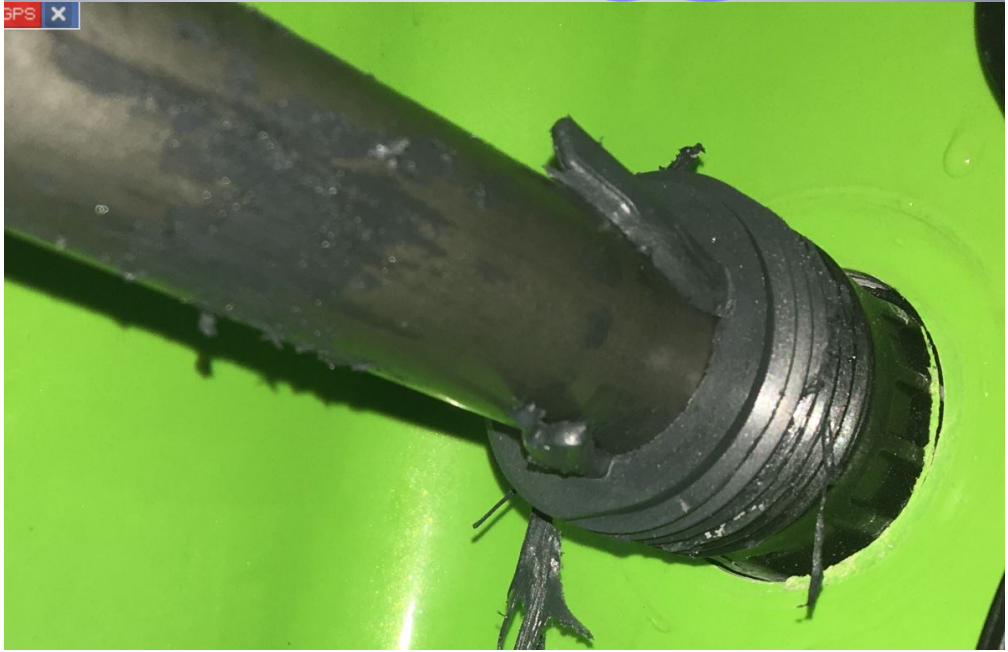
- Ensure the iBR gate movement is not obstructed in any way
- Ensure the iBR gate mechanism is in good condition and does not show signs of excessive wear, impact or high friction that would prevent it from moving or causing it to move slowly.
- the moving shaft (see illustration below) does not have any sealant on it, preventing it from moving
- overtightening of the moving shaft can jam the gears in the iBR creating faults and/ or noise (squeaking)
When installing the moving arm in the iBR, DO NOT OVERTIGHTEN. It must be loosened in order to line up with the moving gate

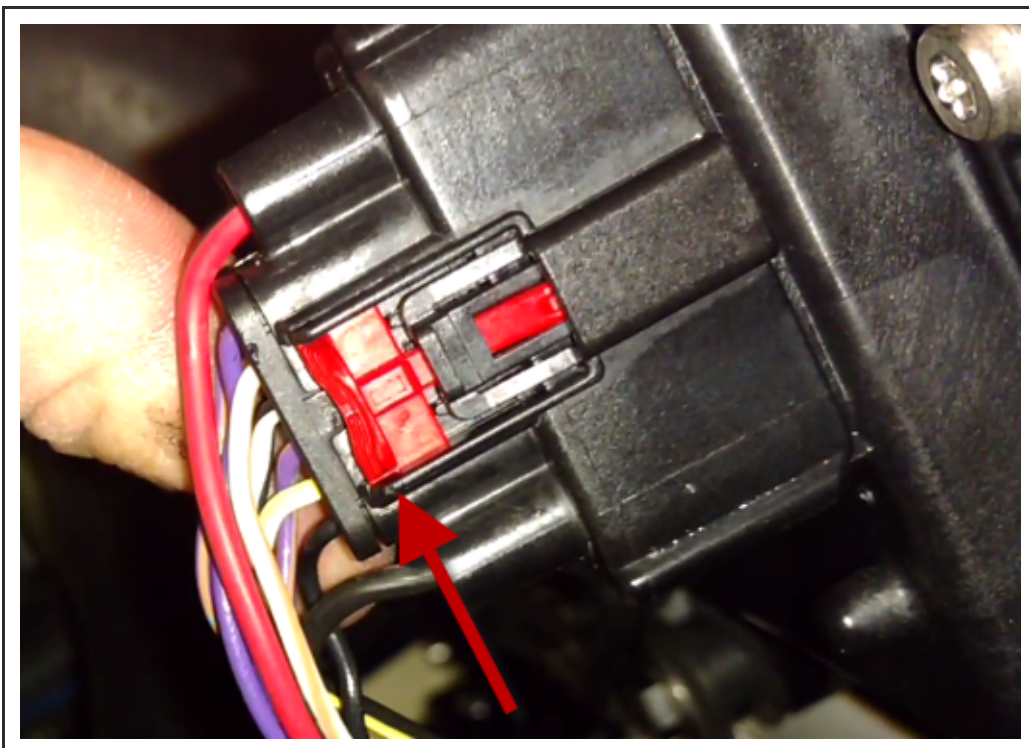
Red locking tab must be in the "unlock" position to remove the connector

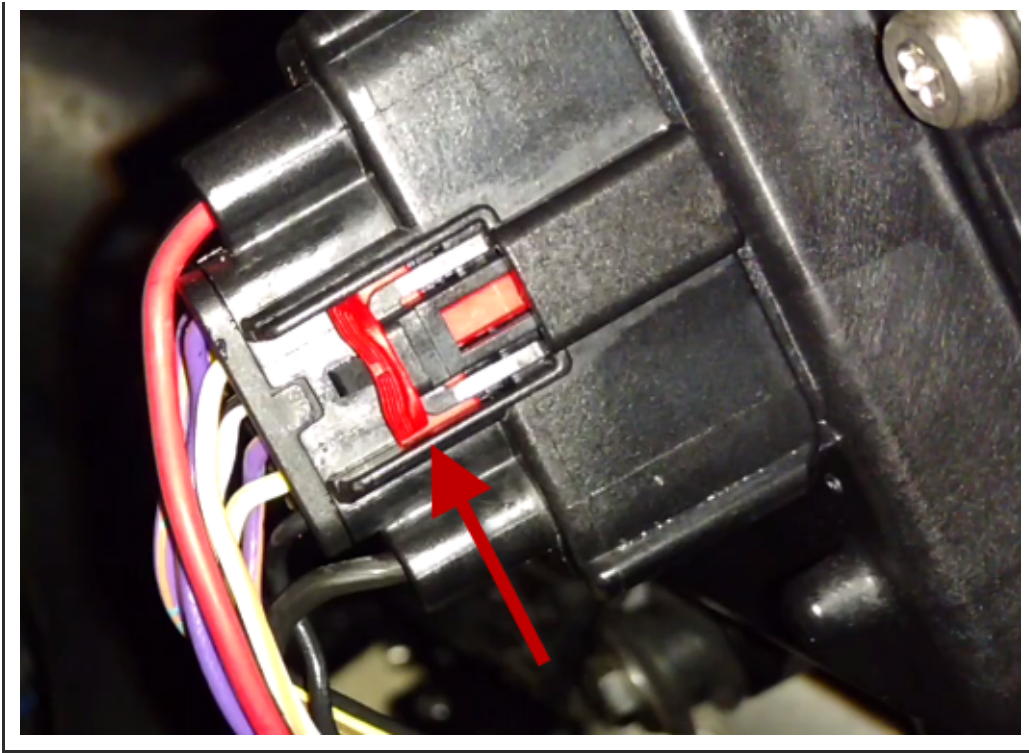
The red locking tab CAN be pushed in the "lock" position before inserting the connector and it can still go all the way in. However, if you don't hear the "click" noise from the retaining clip, this means that the connector is not fully connected. The red locking tab can lead you in the wrong direction... Don't think that you connected it correctly just because the red tab can be pushed in the lock position! Try pulling it back out after locking it.

Red locking tab CAN be in the "locked" position even if not connected all the way in

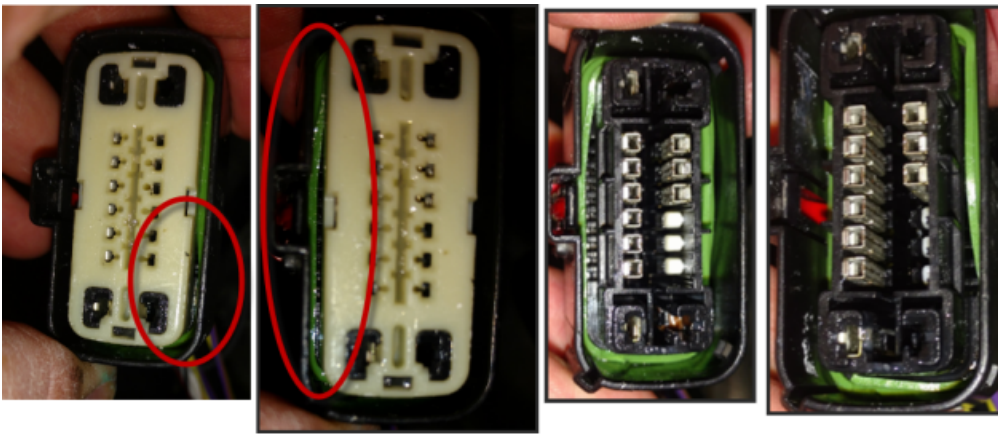
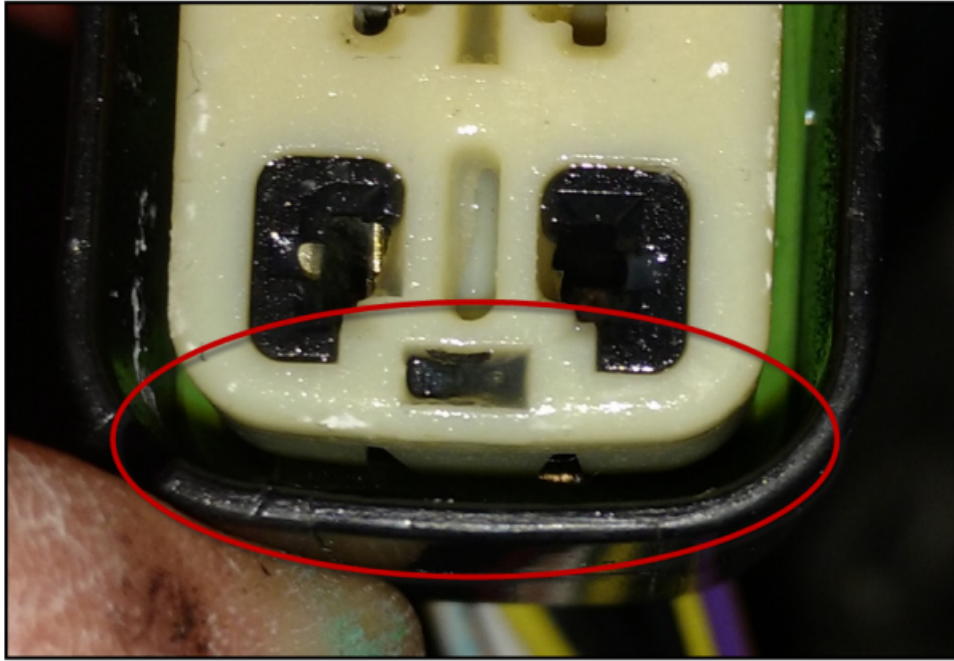
More than likely the connector's seal has moved out of its location and is being pinched. It's a little hard to see when the white plastic piece is in place but look closely or pry it out, you may have a surprise!

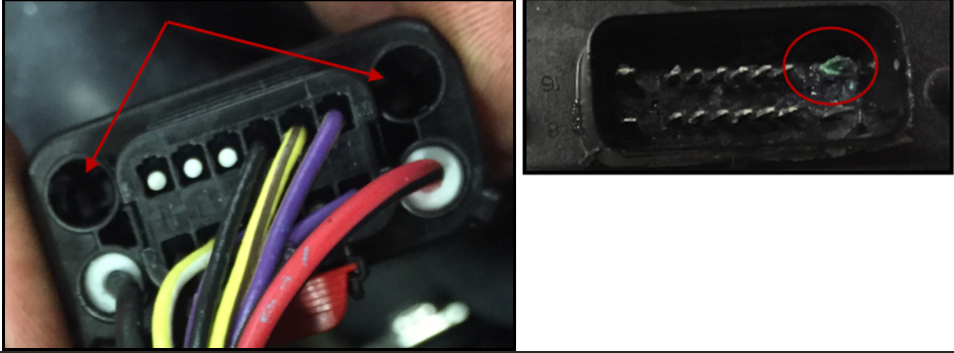
When the above seal is damaged, water may infiltrate. In saltwater, it is even more critical to have a good seal. Corrosion will occur and it can also happen from a bad wire seal. A brown sealant is used to seal the 2 large, unused, terminals.

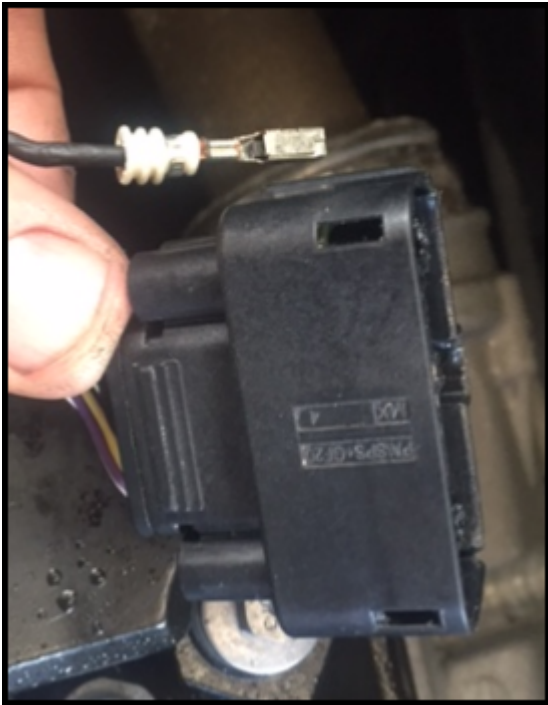
Terminal pushed out and loose terminals

A terminal may not be fully inserted and move out of the connector during installation. This can cause various faults. A simple pull test is best to confirm the terminal is locked in place or, use the appropriate terminal tool.

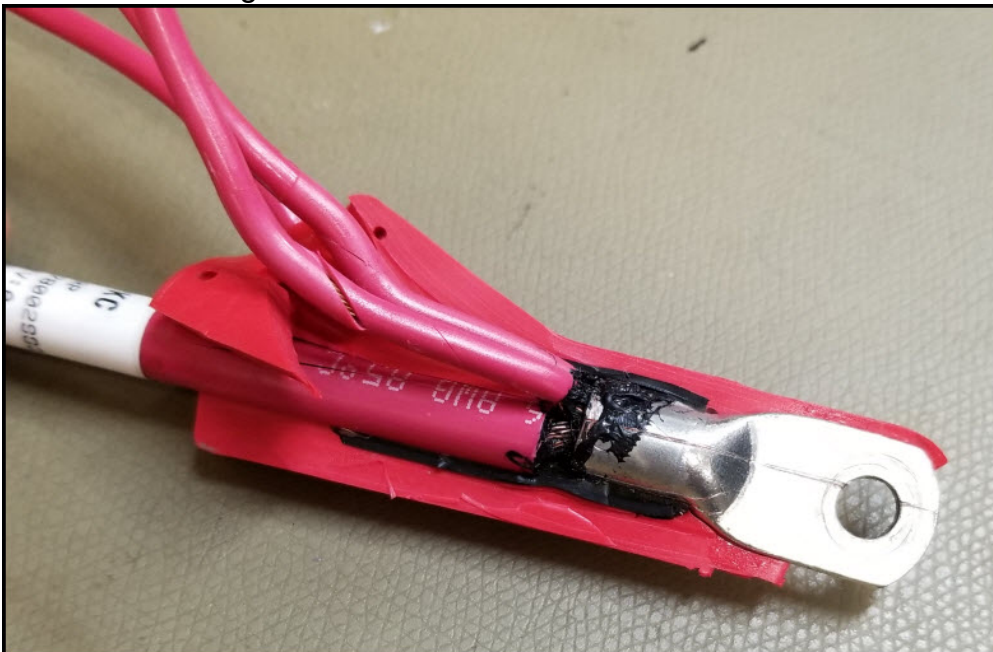
The junction at the starter relay may be corroded inside the rubber-coated junction. this could also allow water to migrate in the fuse box.

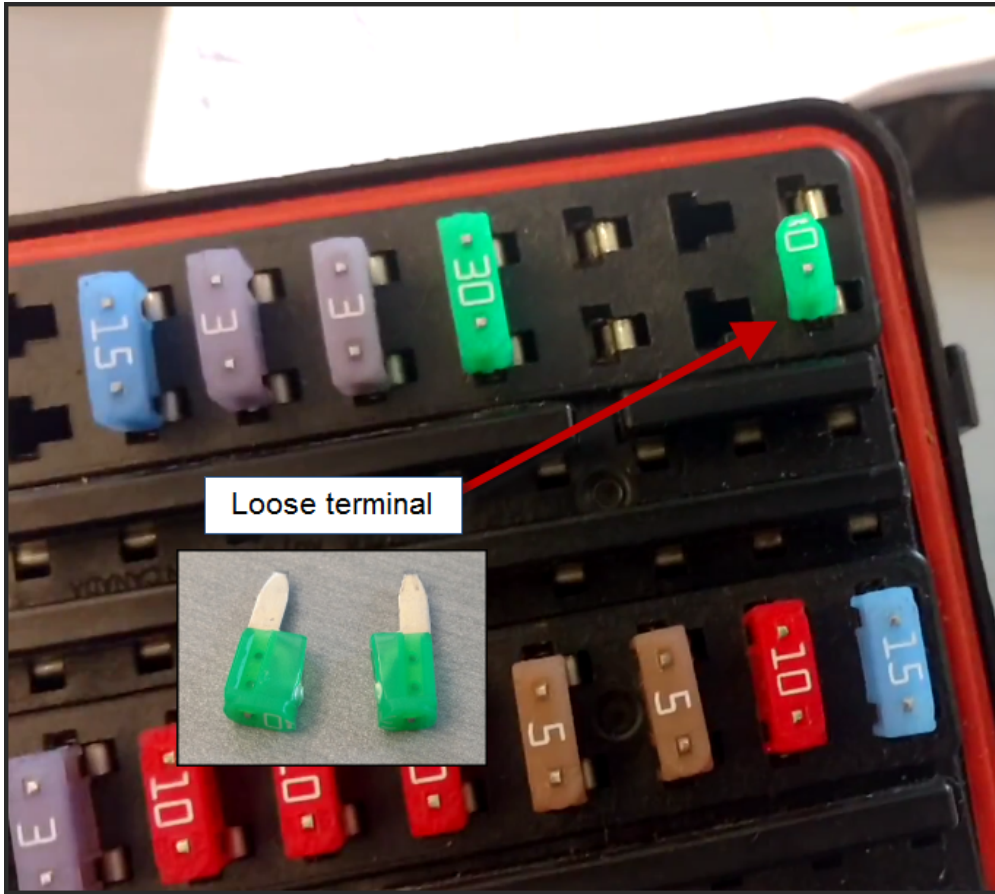
A few loose terminals were reported on the 30amp fuse also. You may want to cut a fuse and use it

as a terminal testing tool. When inserting and removing the fuse into the terminal, resistance should be felt.

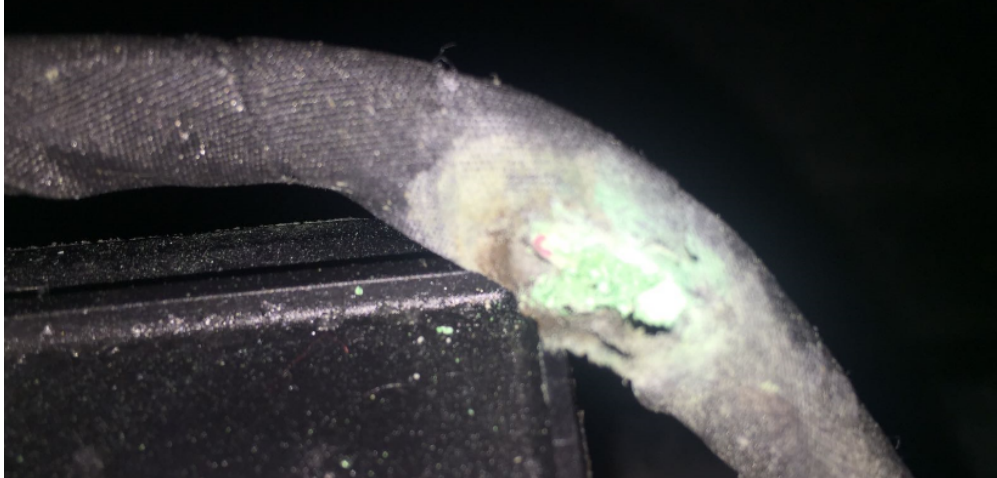
The faults below were caused by the main harness chafing on the intake manifold.

In this case, the most important fault is C2161 Low voltage detected. Low voltage will trigger many other faults.

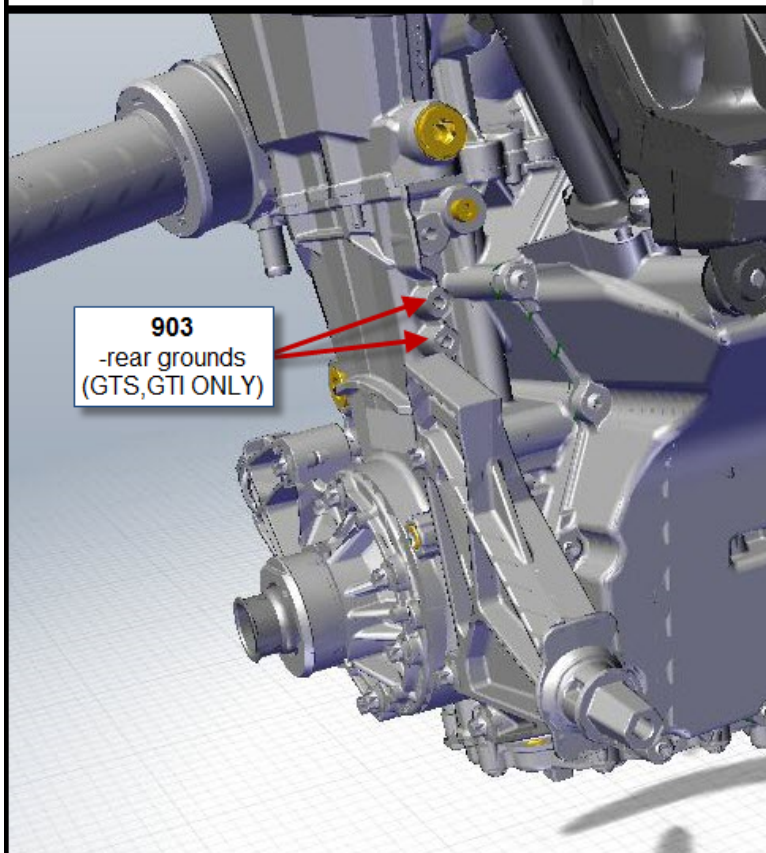
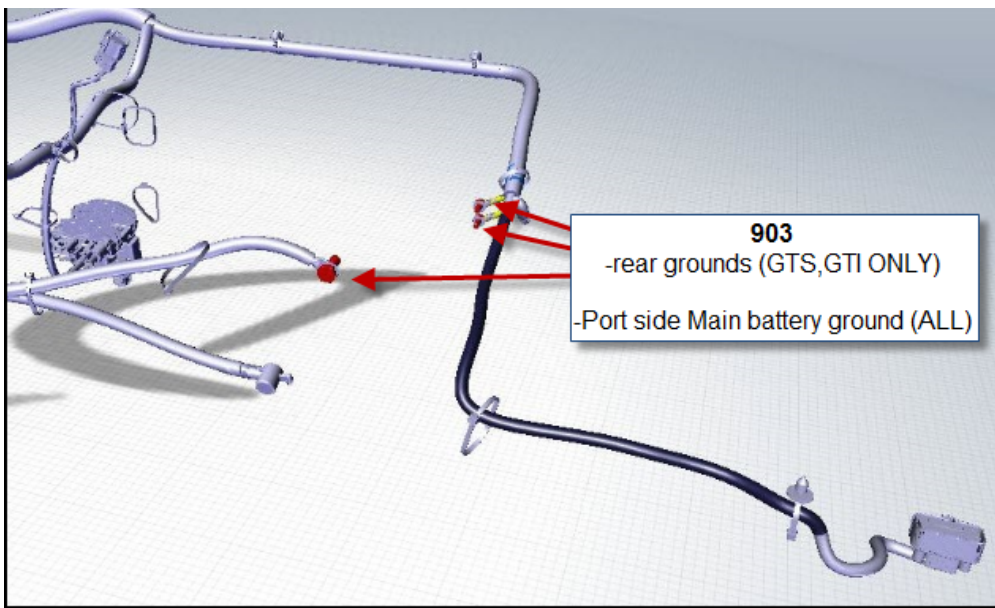
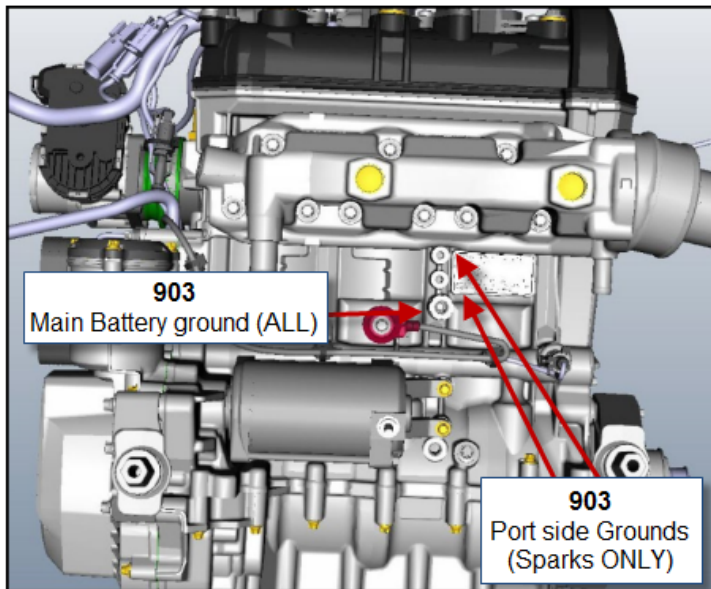
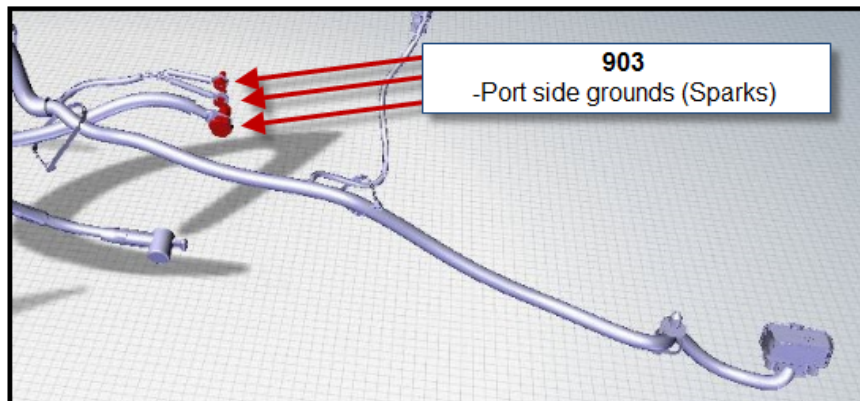
Some loose grounds have been reported.

In some cases it would trigger a low voltage fault. In other cases, it would cause the iBR to shut down and not communicate on the CAN. U0129, U16A4, U16A5.
