PWC Gen2 iBR Diagnostic Tips - Electrical Explained - 133416

Troubleshooting best practices with detailed view of the iBR connector, verifications to perform, and what to watch out for.

Problem

Many iBR's are replaced due to incorrect diagnostic. After further analysis, external problems are found to be the cause of the iBR system fault.

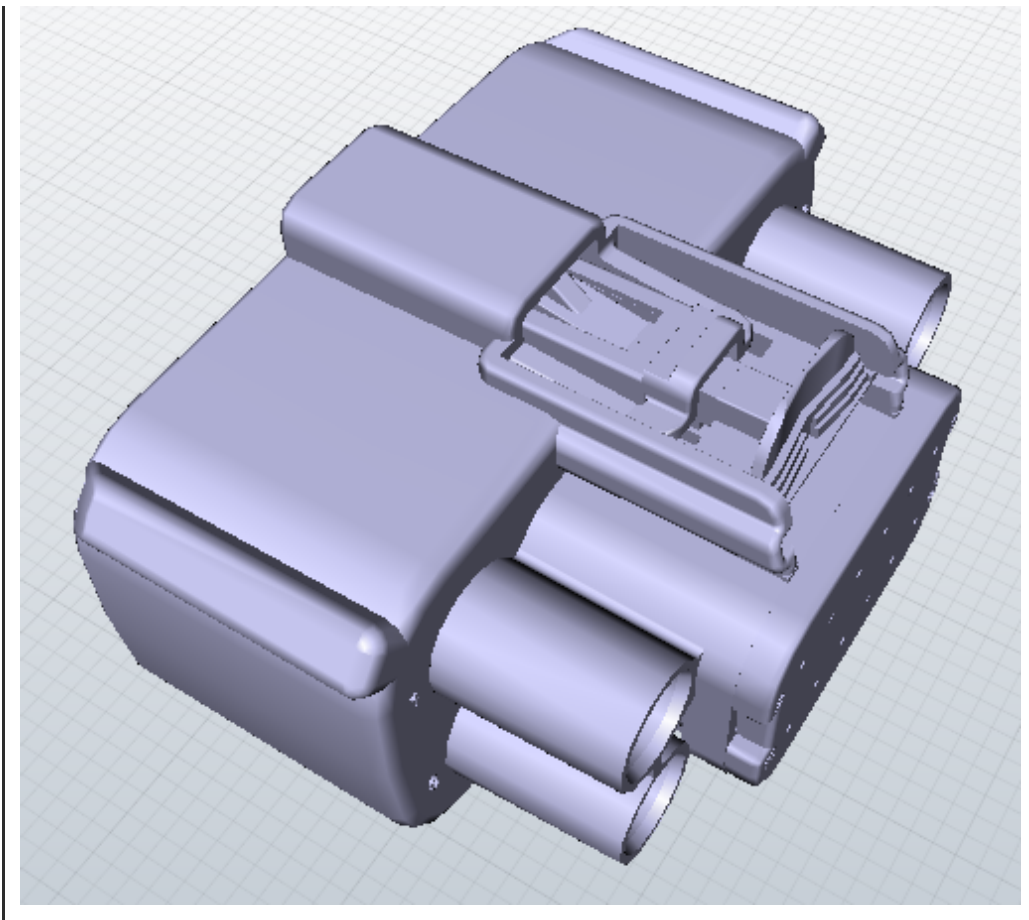
When installed properly the iBR connector offers superior performance under submerged water.

The red locking tab CAN be pushed in the "lock" position before inserting the connector and it can still go all the way in. However, if you don't hear the "click" noise from the retaining clip, this means that the connector is not fully connected. The red locking tab can lead you in the wrong direction... Don't think that you connected it correctly just because the red tab can be pushed in the lock position! Try pulling it back out after locking it.

It is good practice to disconnect and reconnect any component that is being troubleshot.
