WARRANTY BULLETIN WARRANTY CAMPAIGN

Campaign no.: 2024-0004

July 9, 2024 Subject: **Software Update for the 10.25" Touchscreen Display:
Includes Apple® CarPlay® and Other Improvements**

No. **2024-4**

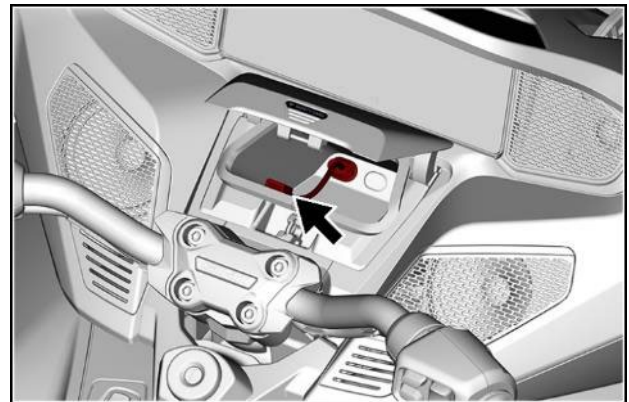
NOTE: The USB connector is located inside the glove box for F3-T, F3 Limited and RT models, or inside the front storage compartment for F3-S model.

TYPICAL – F3-T, F3 LIMITED AND RT

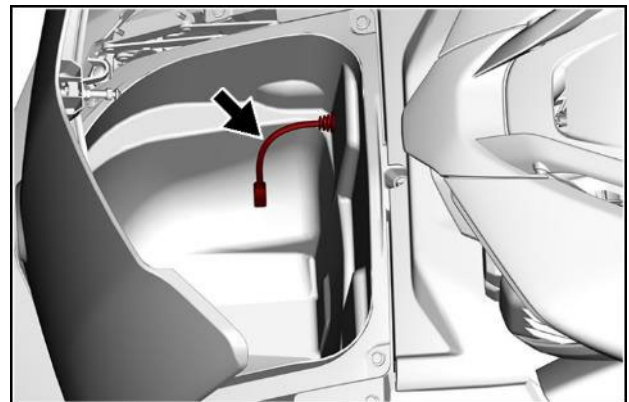
TYPICAL – F3-S

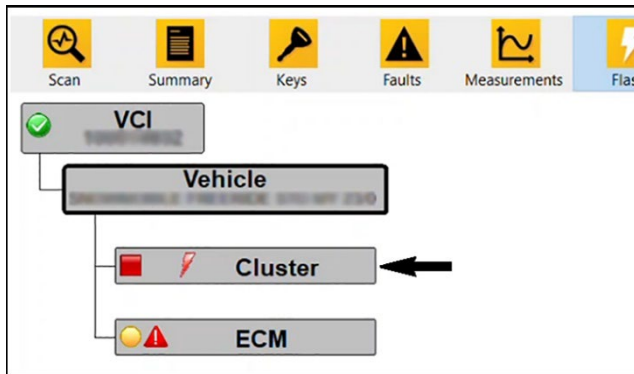
3. Connect the vehicle to the BRP diagnostic software (BUDS2).
4. In BUDS2, go to:
 - **Flash** page

If the **Cluster** tab has a red square, this indicates it is blank (service part).

If the **Cluster** tab has a lightning bolt, this indicates an update is available.
